CAPITAL REPLACEMENT RESERVE FUND STUDY

April 2017

Condominium Corporation 8820814

Operating as: Birchwood County Condo

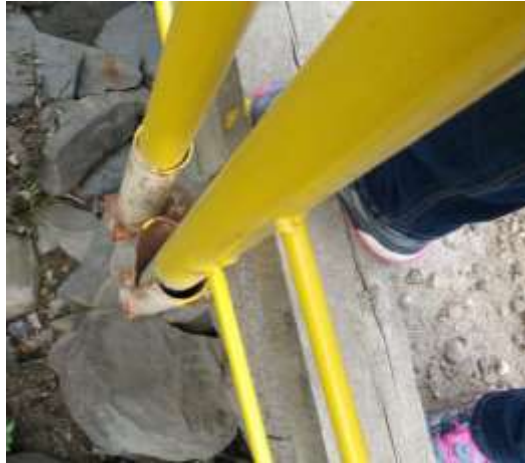
1. The guard rail metal sleeve has been damaged and needs repairing to keep the guard rail from falling into the creek (see Figure 2).

Figure 2: Sleeve needing repairs

Item		Cost Estimate
Bridge Repairs		
	Deck Board replacement w/ Labor	\$1,480.00
	Grading around Access/Exit w/ Labor	\$1,050.00
	Sleeve Repairs w/ Labor	\$740.00
	Bumper Pad Repairs w/ Labor	\$345.00
	Removal of Vegetation w/ Labor	\$650.00
Water Distribution Systems		
	Water Leak Detection - Estimate	\$4,000.00
Cedar Glen		
	Metal Vents w/ Labor	\$150.00
	Development/Building Permits	\$500.00
	Soffit & All Trims w/ Labor	\$288.00
	Electric Panel Heater w/ Labor	\$500.00
Aspen Grove		
	Metal Vents w/ Labor	\$150.00
	Electric Panel Heater w/ Labor	\$500.00
Willow Ridge		
	Methane Monitor w/ Labor	\$250.00
	Shingles (30 yr) w/ Labor	\$1,018.00
	Electric Panel Heater w/ Labor	\$500.00
TOTAL MAINTENANCE BUDGET CONTRIBUTION		\$12,121.00

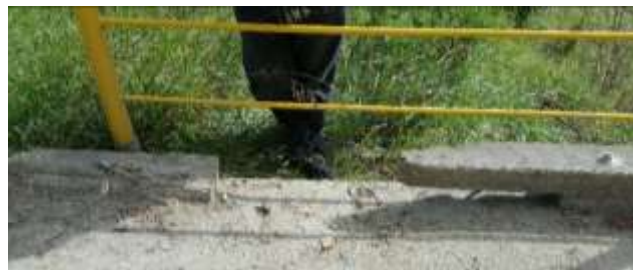
2. Surface deck boards are in need of replacement on the North and South ends. Repeated vehicle impact on the deck surface should be monitored yearly and allow for a depreciation of approximately $\frac{3}{4}$ ". If the deck boards become brittle and flake off, they should be changed earlier than scheduled.
3. Bumper Pads are generally in decent shape but are starting to show wear. In particular, the bumper pad at the North end is in poor shape (see Figure 3) and requires replacement in the upcoming year. The remainder of the bumper pads need to be monitored yearly.

Figure 3: Bumper Pad to be replaced

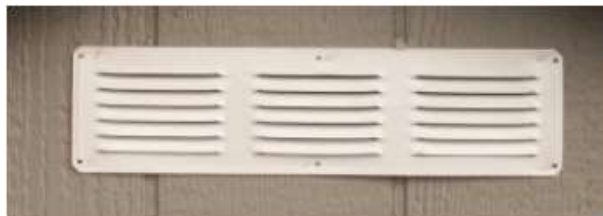
Figure 4: Metal gable vent

1. Hire a third party company to find the water leak (this has been started and completed in September/October 2016).
2. Increase the water distribution building to accommodate more space for the existing equipment. The water tank is spanning over a large hole and the only support under the tank is plywood. An addition of approximately 6' x 12' would be recommended.
3. Ventilate the building with two metal gable vents as shown in Figure 4 (or equivalent).

1. For costs savings and less time replacing the heaters, it is recommended that an electric panel heater that is suitable for wet locations be installed in replacement of the portable space heaters.
2. Ventilate the building with two metal gable vents as shown in Figure 4 (or equivalent).
